REPORT OF ASBESTOS CONTAINING MATERIALS
SURVEY AND MANAGEMENT PLAN
LONG BEACH U.S. ARMY RESERVE CENTER
SCHROEDER HALL AND OMS BUILDING
LONG BEACH, CALIFORNIA

Survey also includes a limited PCB Label Inspection of transformers

ADECCO / TAD TASK ORDER DA7-000001559

Gil Bakshi
Certified Asbestos Consultant #99-2650
29 January 2001

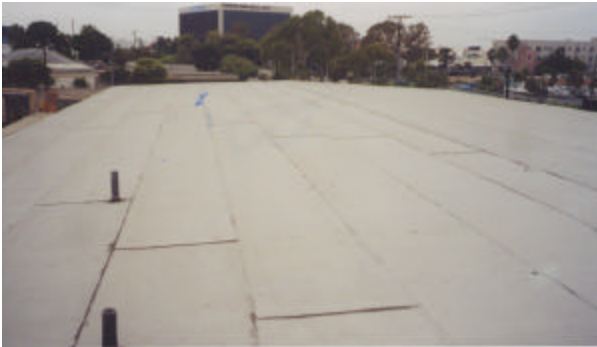
The roofs of the Administration Building and OMS Building had been replaced since the HLA survey (1999/2000). Facility personnel were unable to identify records that transite on the roof had been completely removed.

Roof of Administration Building (New)

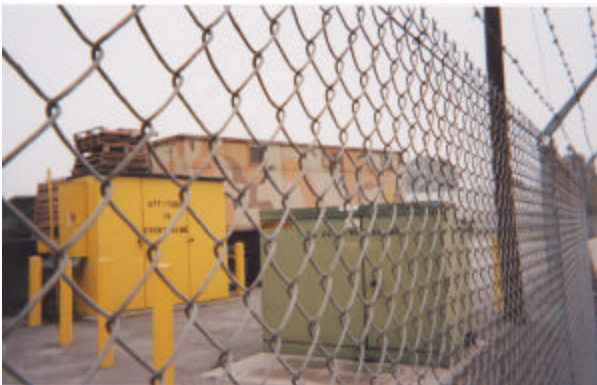
Transformer on Site
